Colorado: Extended Temporary Sign Post

- Lawrence Wilke and Joe Willits
CDOT Colorado Springs

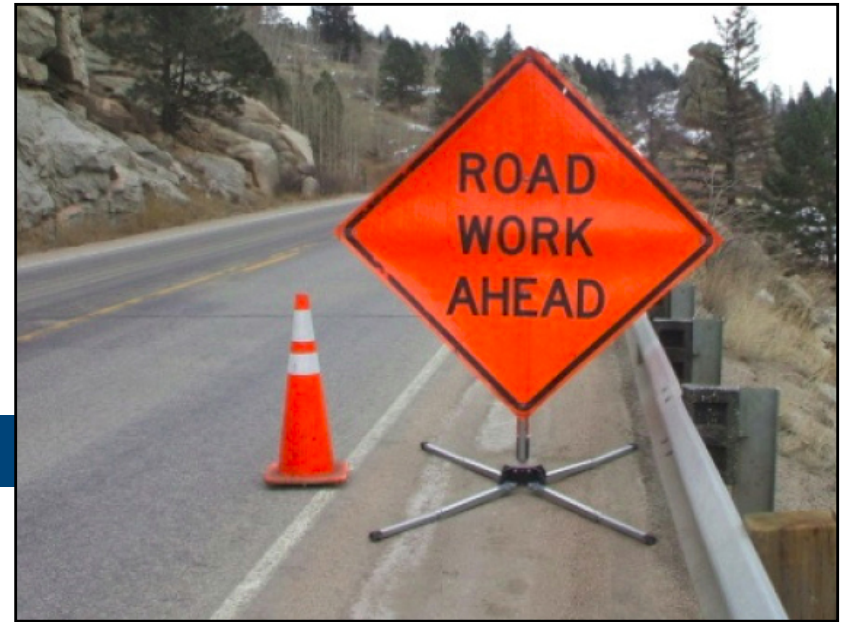
Problem

- Many 2 lane mountain roadways have little or no shoulder along areas with metal post guard rail.
- Temporary sign placement becomes an issue due to:
 - Signs and stands encroach into lane of traffic, causing larger vehicles to cross the centerline into oncoming traffic.
 - Signs obstruct visibility of motoring public on narrow winding roadways.

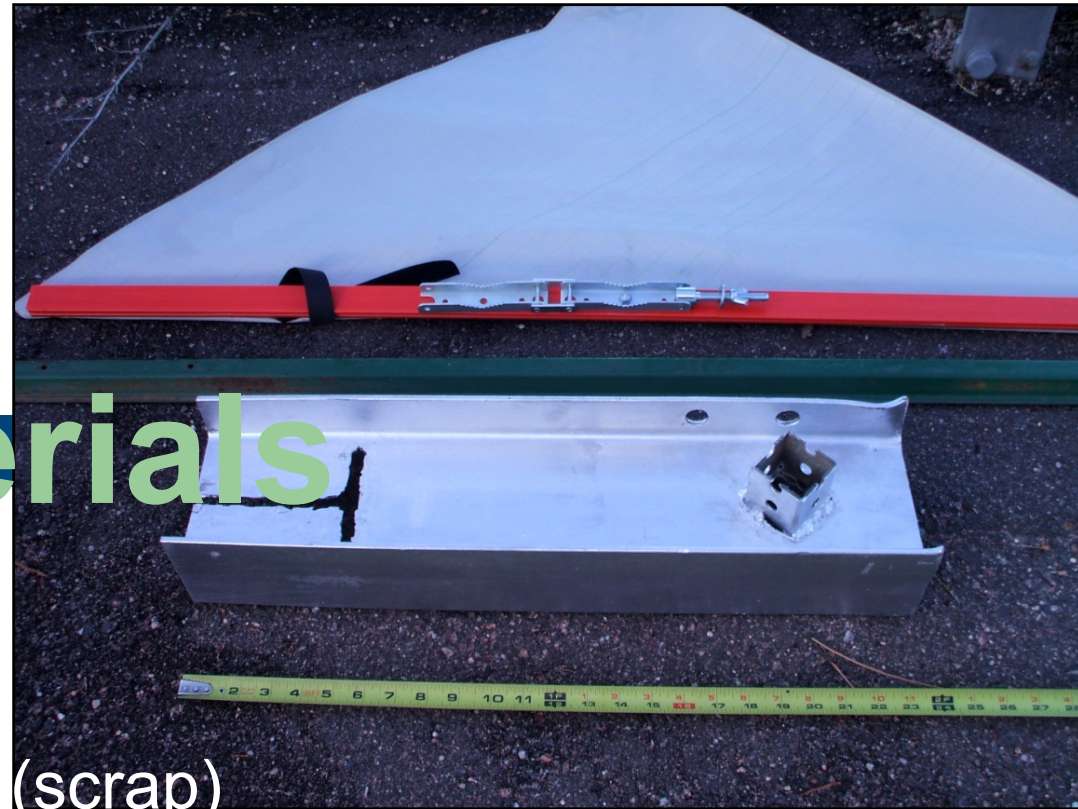
Labor & Materials

- 24" of steel guard rail post (scrap)
- 3" of angle iron (scrap fence brace)
- 3" of square tube (scrap from the county sign post)
- Small amount of cutting and welding material
- Cost to fabricate 1 device is ~1 labor hour

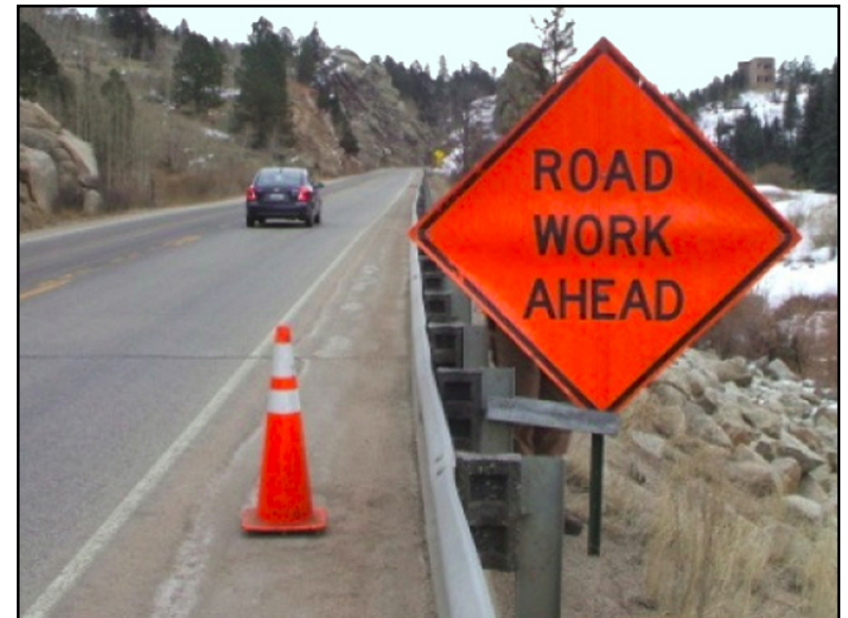
- Keeps driving lane unobstructed and improves driver visibility.
- Safer environment for maintenance personnel and drivers.
- Used with both *cloth* and *metal* signs without any problems.
